# REFLECTIONS ON MATERIALS AND METHODS FOR LATRINE PIT DESIGN

## Key Findings and Recommendations

**June 2024**

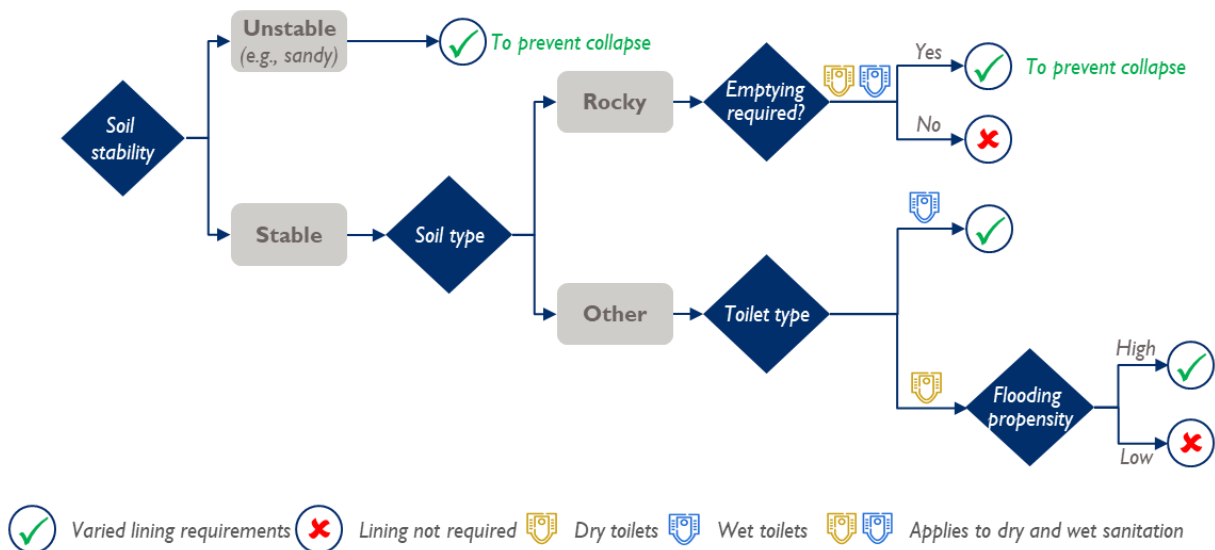
**Figure 1: Conditions warranting pit lining**

Ideally, pit latrines are designed to hygienically contain and separate fecal waste from human contact and enable the treatment of their contents in situ, which generally requires interaction with the surrounding soil. An additional design consideration is whether to line the pit. Not all pits need to be fully lined, though all masons/builders should consider utilizing a collar/partial lining for at least the top half meter of the pit, as this provides structural support for the slab (Bob Reed 2014b). Lining decisions must be sensitive to context in design and application (captured as “varied lining requirements” in Figure 1); this diagram does not specify the various lining considerations and requirements for a given context. Additional information on these considerations is provided in Sections 3.2 and 3.3, and further detail on experiences, lessons learned, and potential solutions/options are provided in Annexes A and B. The general takeaway is that latrine pit lining is required in most circumstances, at least of the top half meter if not fully, unless these are dry pit latrines constructed in areas with highly stable soils (e.g., rocky or clay/loam soils) with low or no flooding propensity and that will not be emptied.

Lining often presents a sunk cost to consumers and barrier to affordability, particularly in areas where pits will not be emptied and reused. For this reason, among others, consumers often opt not to line their pits or to use low-cost locally available materials in contexts where lining is needed for structural stability, or not install a latrine until they can afford one with a lining. Choosing not to line a pit when lining is needed may result in collapse, whereas choosing to line a pit when lining is not needed (or choosing a lining option that is not best fit for that context) may represent an unnecessary expense. Poorly designed or unnecessary lining can result in increased fill rates and subsequent unsafe emptying or abandonment, with increased costs to consumers or a delay in installation.

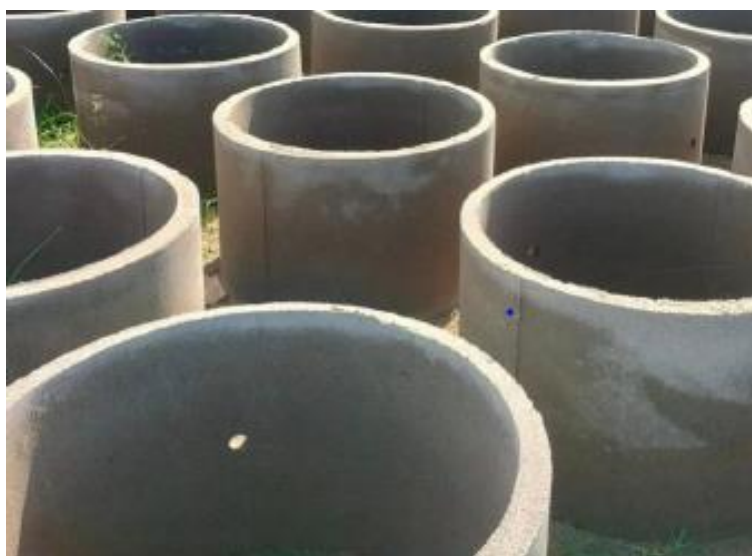
Two concrete mixtures and associated designs are currently implemented: dry concrete rings (Figure 2) and wet concrete rings (Figure 3), both used for wet pit latrine applications. The dry concrete rings have a diameter of 0.8 m and a relatively high quantity of gravel and large aggregate to increase porosity and exfiltration. The wet rings have a diameter of 1.0 m and are a more standard concrete mixture, but due to their low porosity and correspondingly higher fill rates, they are made larger to hold a higher volume. The dry rings break more easily than the wet rings, resulting in transport challenges and associated higher costs. Wet rings have a higher production cost and are also often used in flood-prone areas in Cambodia, featuring stilts with pipes that run into the ground (Sky Latrine design, see Figure 3). However, latrines with both dry and wet rings are subject to quicker fill rates due to poor seepage in clay-heavy and other densely packed soils in Cambodia. iDE has installed over 400,000 Easy Latrines in Cambodia using these dry and wet ring designs. This product has shown high marketability in the Cambodia context, likely thanks to its correspondence to household aspirations for higher end products, the price-point in range of consumer willingness-to-pay, a road network facilitating transport of the rings, and relatively high rural density aiding sanitation business viability. The wet and dry concrete rings were designed for the Cambodian market and have not been marketed elsewhere, though concrete rings in general have been employed for pit lining across most of Asia and much of sub-Saharan Africa. Their potential to address affordability, availability, and acceptability constraints is unlikely in most African contexts due to poor road conditions and networks, lower willingness to pay, and more dispersed rural populations. Further exploration of these concrete ring mixtures and modifications should focus on contexts where they have the strongest potential for successful marketing, sales, and adoption, including other Asian contexts.

**Figure 2: Dry Ring for iDE’s Easy Latrines in Cambodia (source: iDE Cambodia)**

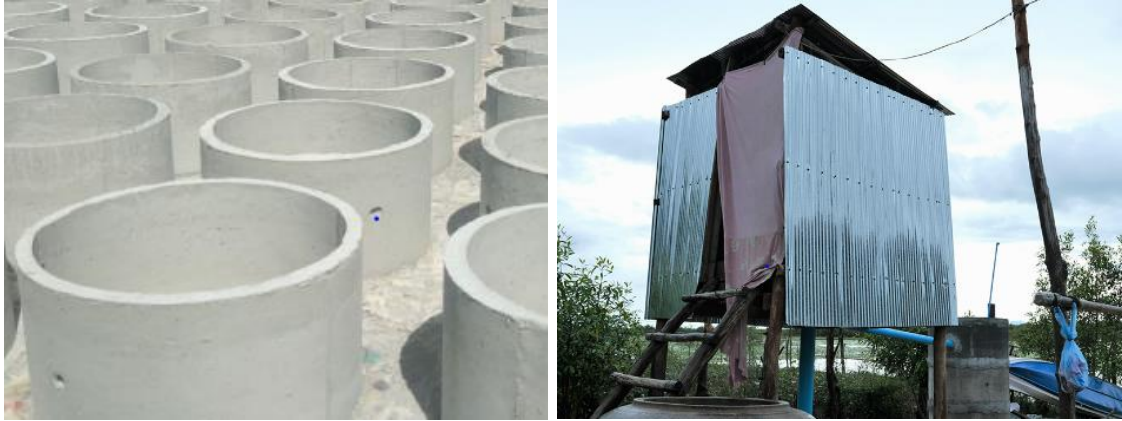
**Figure 3: Wet Ring for iDE's Easy Latrines in Cambodia (left, source: iDE Cambodia), used for Sky Latrines constructed on stilts for seasonally flooded areas (right, source: Water For Women Fund)**

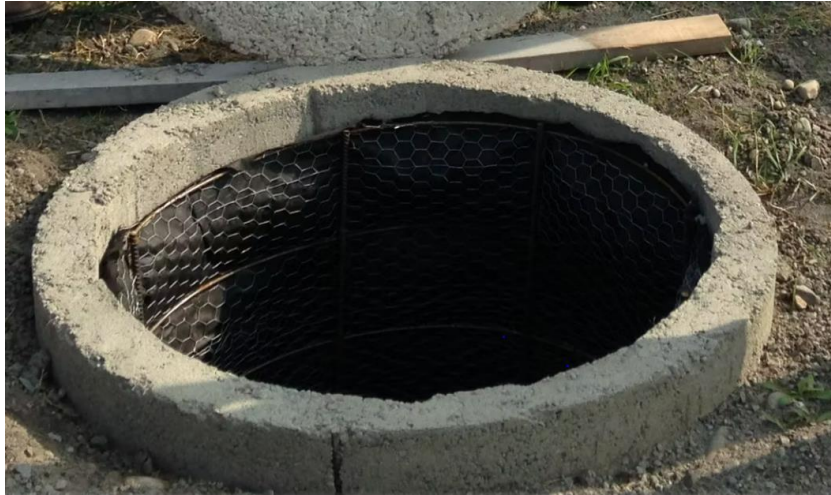
[Rebar-reinforced fabric lining](#) (Figure 4) is another viable alternative, costing up to approximately USD 40 per lining for a latrine with a depth of 1.5 meters and a diameter of 1 meter (Grossnickle et al. 2017). Most of the cost is from the rebar, though scrap materials may be able to reduce the cost if available locally. Rebar-reinforced fabric linings have been demonstrated to withstand soil pressure and hold shape when used for pit lining. The rebar, wire mesh, and fabric needed are available in most contexts and will allow liquids to leach into the surrounding environment if the fabric is permeable. Depending on the cloth material used, this lining design may resist degradation over time, though it is best suited to dry pit applications to avoid potential rusting of the rebar and mesh and degradation of the cloth. There is no evidence on the longevity of this design, and there is no evidence to date of its widespread

**Figure 4: Rebar-reinforced fabric lining (source: CAWST)**

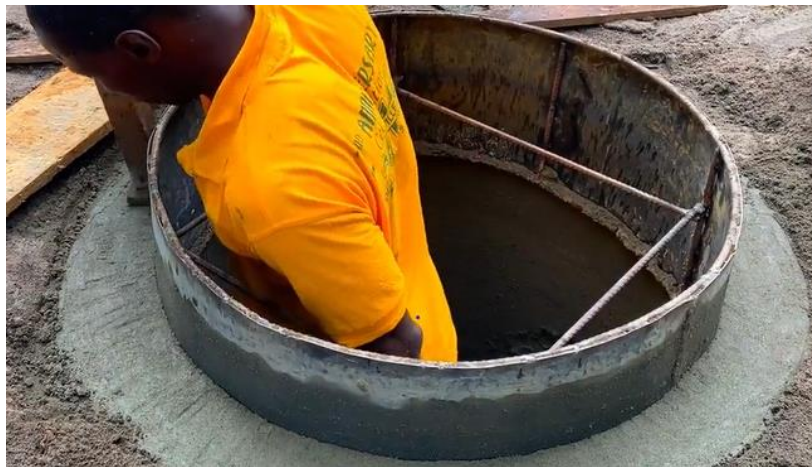
CAWST has piloted [cement reinforced stabilized soil lining](#) in Liberia (Figure 5), initially developed by iDE. A small amount of cement is added to soil excavated from the pit with minimal water, and placed in between the pit walls and a mold that is placed in the center, leaving a gap for the lining to fill. While the mold itself may be difficult to acquire, materials are otherwise widely available, and labor/installation costs are low. Given that this method utilizes locally-available resources in most markets and does not require heavily-skilled labor, it may present a cost-effective and marketable option.

**Figure 5: Construction of cement-reinforced stabilized soil lining (source: CAWST)**

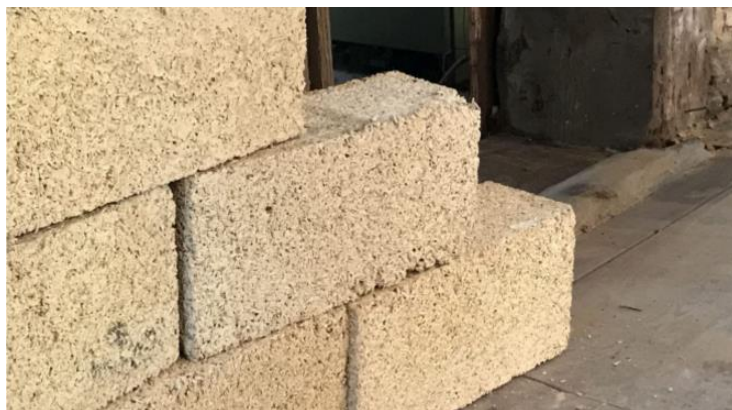
Natural fibers such as hemp are increasingly used in concrete alternatives. Hemp is the longest and strongest natural fiber in the world, with promising construction applications in low- and middle-income countries (UNCTAD 2022, Ahmed et al. 2022). Hempcrete is created by binding the core fibers of hemp with lime as a binding agent and is one-eighth the weight of concrete (Roberts 2020). The legality of growing and processing hemp varies around the world, however, with many countries facing legal battles to its widespread use, particularly in sub-Saharan Africa. South Africa currently has the continent's only [hempcrete manufacturing facilities](#). Prices for a 30 cubic centimeter block of hempcrete (Figure 6) can range from approximately USD 20–30, depending on the country and market. For comparison, a standard concrete block in Uganda (as in many other countries in sub-Saharan Africa) costs less than USD 1 (Daily Monitor 2020). Beyond manufacturing, cost, and legal challenges, the material's capacity to retain water, resulting in swelling and eventual decay if not sealed or treated, renders hempcrete less suitable for the moist conditions of even dry pits. Additionally, there is a lack of evidence of its compressive strength and ability to be used for load-bearing construction; there also is limited evidence of its use for subterranean and soil-retaining purposes. Hempcrete therefore does not present a strong case for further testing for pit lining application and marketability.

**Figure 6: Hempcrete blocks for residential construction (Source: HempBuild Magazine)**

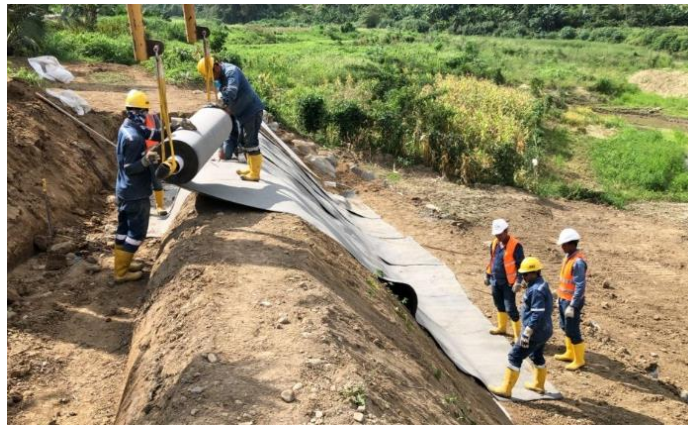
Concrete cloth, or [concrete canvas](#) (Figure 7), is another alternative to standard pre-cast concrete lining rings. Common construction applications include road pavement, culverts and channels, and emergency response settings. It is widely regarded for its ease and speed of installation and is available in many countries across North America, Europe, Asia, and Africa. The material is commonly sold as a roll or large sheet, which is molded into the required shape, covered in cement in overlapping areas, nailed or otherwise fastened, and then saturated with water, hardening as it dries. Concrete cloth sets within 24 hours at up to 80 percent strength, continuing to gain strength over time. The product is lightweight and compact and may thus reduce transport costs compared to pre-cast concrete rings. Costs range from USD 20–50 per square meter, for a pit latrine with a depth of 3 m and a diameter of 1 m this lining would cost around USD 200-500.<sup>3</sup> It often comes with a PVC backing on one side for impermeability, which may limit pit effectiveness if not removed. This solution holds potential for both wet and dry pit

**Figure 7: Rolling out concrete canvas during construction (Source: Geosynthetics Magazine)**

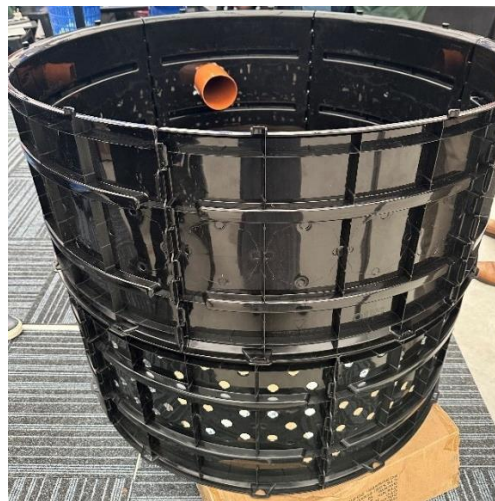
The [SATO Pit Liner by LIXIL](#) (Figure 8) is currently in the prototype stage with ongoing field testing in India, Uganda, Malawi, and Zambia. The current design has proven to withstand substantial soil pressures and features plastic panels that fasten together to form rings, which can be stacked and fastened before being placed in the pit. The lower portion of the plastic lining is perforated to allow leaching into the surrounding soil, though a design for flood-prone contexts is underway and will likely be fully sealed. A set of 18 panels is likely to cost USD 65–75.<sup>4</sup> While the lining will currently need to be imported and transported to the site in most contexts, it is very lightweight and compact in size, making it a suitable alternative to standard lining materials in hard-to-reach areas. The SATO Pit Liner is designed to be implemented with the SATO pan and is thus well suited to wet pit applications, and it would also function well for dry pits. As the product is still in the prototype stage, further testing is recommended to confirm broad marketability, including consumer response and satisfaction, willingness to pay, and ease of incorporation/integration into existing supply chains and product offerings by local sanitation businesses or hardware store owners.

**Figure 8: SATO Liner prototype at the AfricaSan 7 conference (source: Carolien van der Voorden)**

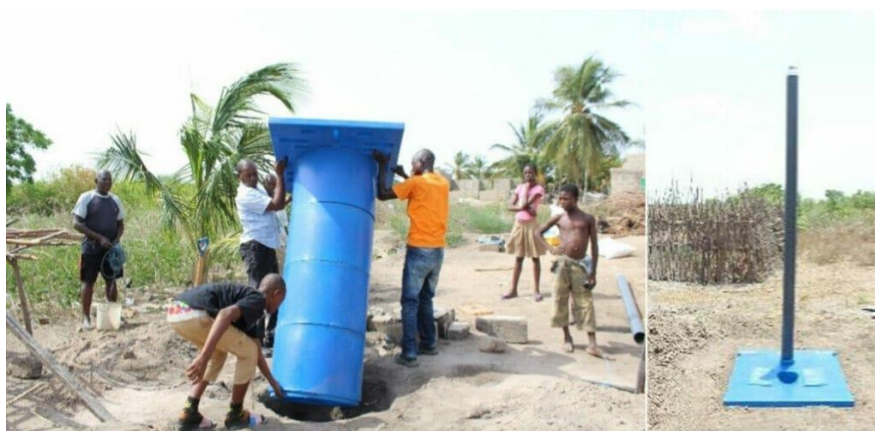
**Figure 9: Digni-Loo installation in Ghana, showing the full lining (left) and the final installed product (right) (source: Global Communities Ghana)**

The Digni-Loo in Ghana is a plastic molded pit lining connected to a plastic slab (USAID 2017). The Digni-Loo is cited to take 1–5 years to fill and can last for up to 20 years under the most favorable conditions. To date, the Digni-Loo has reached a moderate level of scale in Ghana where 300,000 units were installed, with limited evidence of its applicability across a wide range of contexts.
